A CAST IRON SOLUTION

The importance of maintaining and preserving cast iron rainwater systems

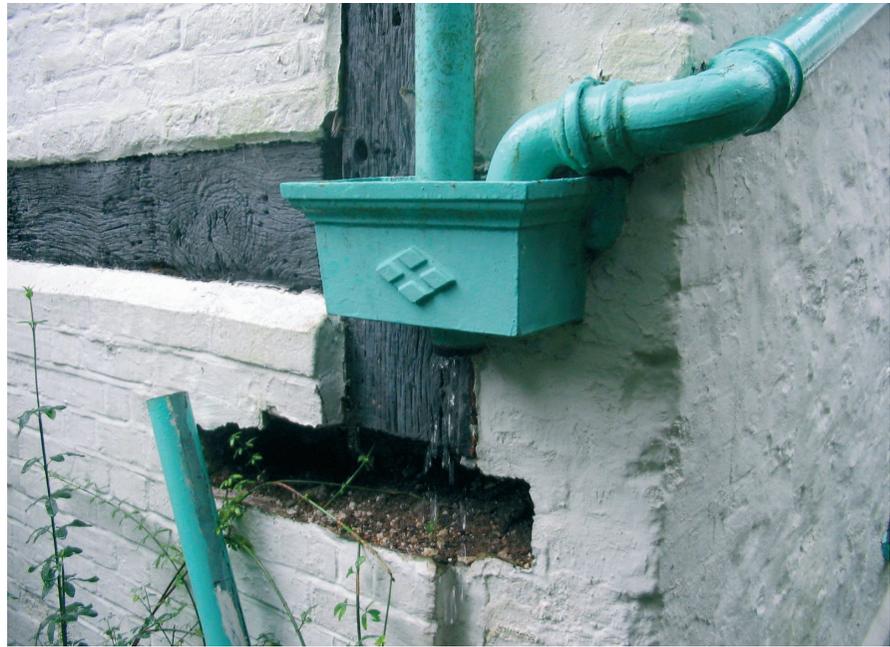
Without proper maintenance, damp and decay caused by blocked, sagging and damaged gutters can lead to expensive repair bills and the loss of historic fabric

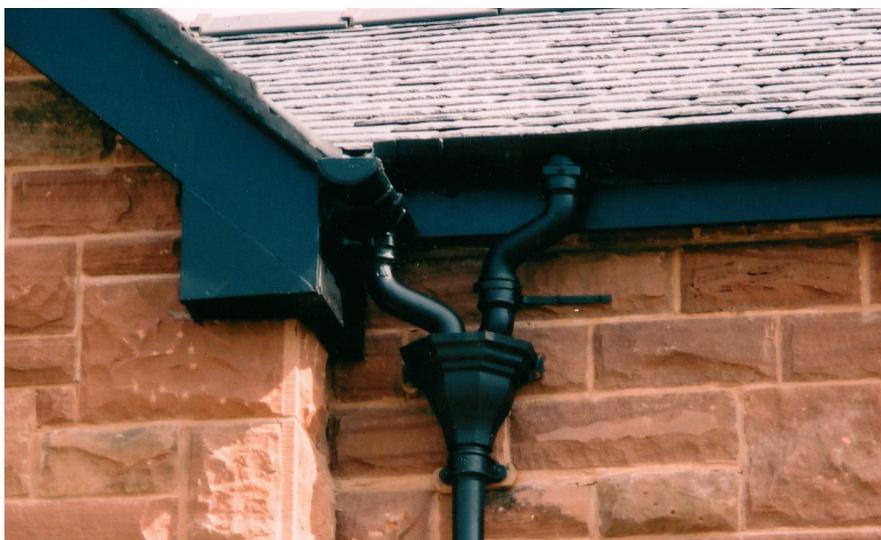
A reproduction of a typical late 19th century hopper with cast iron parapet gutters and simple ear bands on the down-pipe below

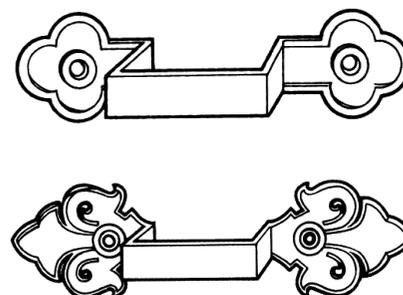
Two designs for decorative ear brackets – in this case for square down-pipes

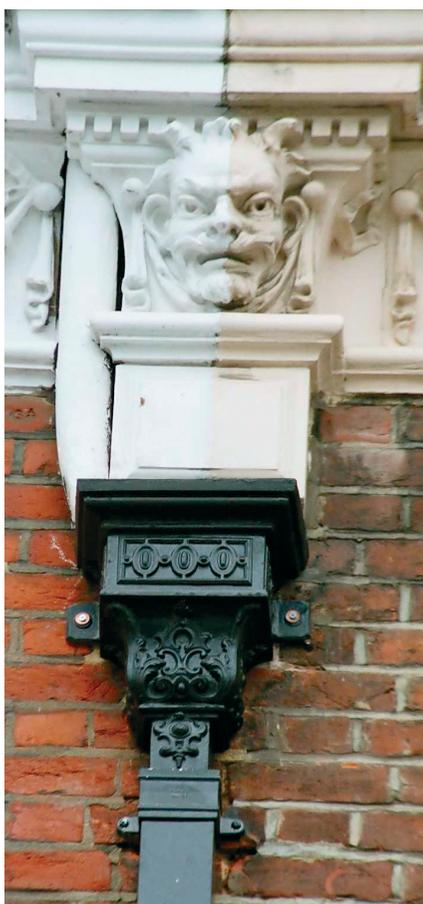
A particularly ornate early Victorian cast iron hopper head which collects water from a parapet gutter behind the fine timber fascia
